Local contamination in Svalbard

Overview and suggestions for remediation actions

Kortrapport/Brief Report no. 044

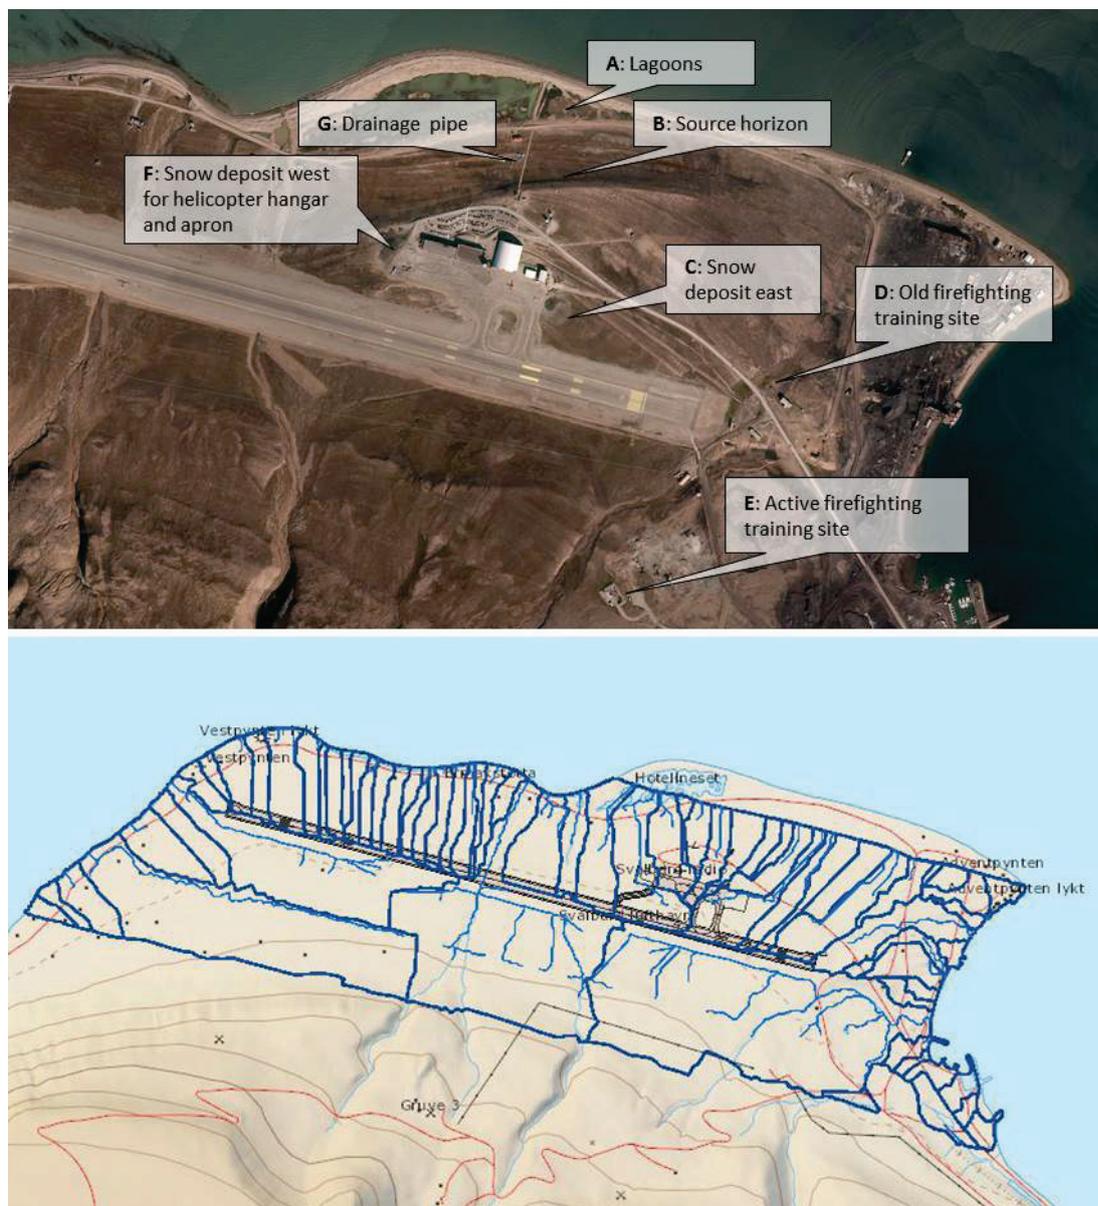
Figure 3. Radar image of the Longyearbyen air- and heliport (top) with some installations and sites associated with handling or storage of hazardous materials indicated: A) lagoons, B) source horizon, C) snow deposit east, D) old firefighting training site, E) active firefighting training site, F) snow deposit west for helicopter hangar and apron, and G) drainage pipe. Radar image courtesy the Norwegian Polar Institute. Bottom map showing land runoff water drainage around the Longyearbyen Airport (Pengerud & Kvisle, 2016).

The Longyearbyen airport is situated on the slope of a moraine. Groundwater drains from the side of the moraine into the Adventfjord. The airport collects part of the drainage water from the working areas and releases it at 18 m depth in the Adventfjord (Fig. 3). A large part of the runoff from the airstrip and working areas does, however, drain directly into the Adventfjord lagoons “Laguner” (Fig. 3-A) and into the fjord itself. The lagoons are frequented by migrating seabirds. Breedveld et al (1999c) reported severe petroleum contamination of soil at the old firefighting training site (Fig. 3-D). This site has mainly been used as an airport firefighting training site. Surface soils also contained degradation products of pesticides (DDT and endosulfan) and PCB. The groundwater at the site was also strongly contaminated with petroleum. The airport has recently been investigated regarding their use and release of contaminating chemicals with particular recent focus on PFCs (Norconsult AS, 2015; Pengerud & Kvisle, 2016; Rudolph-Lund, 2012). PFCs above restricted limits were detected at the old firefighting training site, spreading in an easterly direction. Likewise were PFOS levels exceeding environmental restriction levels at the new firefighting training site, with runoff water containing mainly PFOS (5.5 µg l⁻¹) (Rudolph-Lund, 2012). The most recent environmental assessment of the airport focused on contaminants associated with water runoff draining into the lagoons and Adventfjord (Pengerud & Kvisle, 2016). The investigation showed elevated concentrations of heavy metals, BTEX, THC and PFAS in soil and water samples, indicating that actions should at least be taken to protect adjacent watersheds.

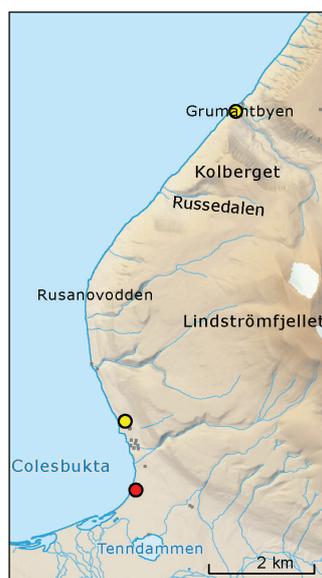
Figure 6. Map of Grumant and Colesbukta showing reported contaminated sites as coloured circles, <http://grunn.miljodirektoratet.no/>. For figure legend see Fig. 2.

The Russian coal mining areas at Grumant and Colesbukta were established in the early 1900s. A small railway transported coal from the Grumant settlement to Colesbukta for further shipping. Coal mining activities were terminated in the 1960s. PCB has been found in paint (up to 160 mg PCB₇ kg⁻¹) and surface soil (average 0.365 mg PCB₇ kg⁻¹) at intermediate levels compared to those found in Longyearbyen and Barentsburg (Jartun et al, 2010). The area around the oil depot in Colesbukta was found to be heavily contaminated with petroleum (Breedveld et al, 1999d) (Fig. 6). A thorough risk assessment with a remediation plan was performed mainly concerning extraction of oil from the two landlocked boat hulls, and removal of the hulls themselves, which have been used for petroleum storage (Havik & Nag, 2009). It is unclear whether the suggested remediation actions have been performed.

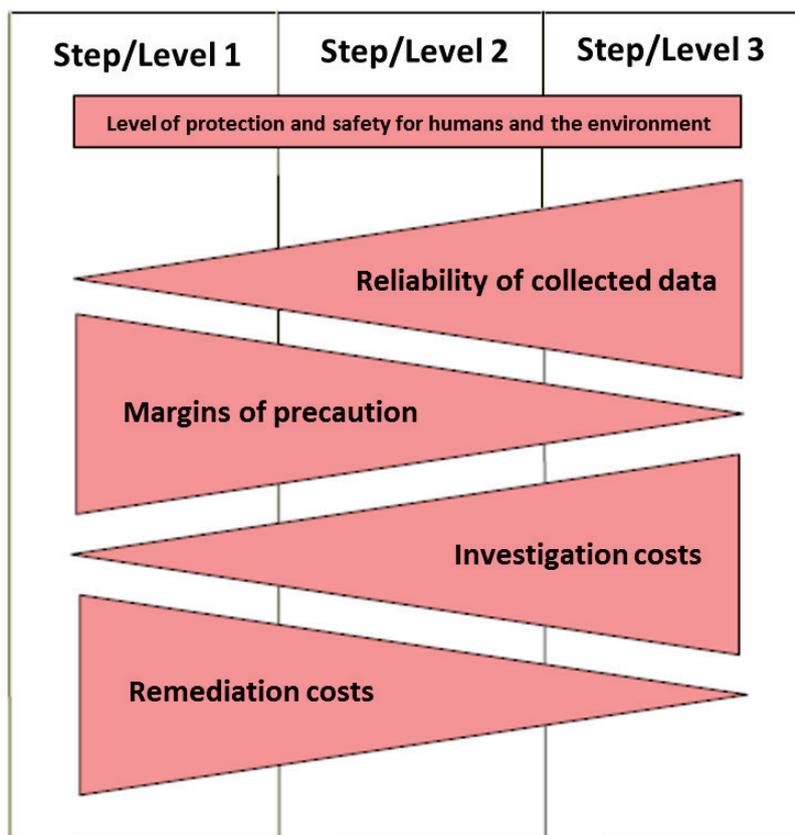
Figure 9. A stepwise structure of the risk assessment procedure aims to enable similar levels of protection for humans and the environment without equal levels of available information or data. Redrawn after Vik et al (1999).

Level 2 - Extended risk assessment (estimated exposure). Exposure routes are identified and worst case scenarios are determined. This involves source, emission, and exposure analysis where episodic events related to seasons (e.g. heavy rainfall, snowmelt) must be included. Acute and chronic exposures are compared to levels of concern and acceptance criteria. Environmental concentrations are also compared to environmental targets. If levels and exposure are exceeded remediation actions must be implemented.

Level 3 - Extended risk assessment (measured exposure). The difference between level 2 and level 3 assessments is that concentrations are actually measured instead of estimated.

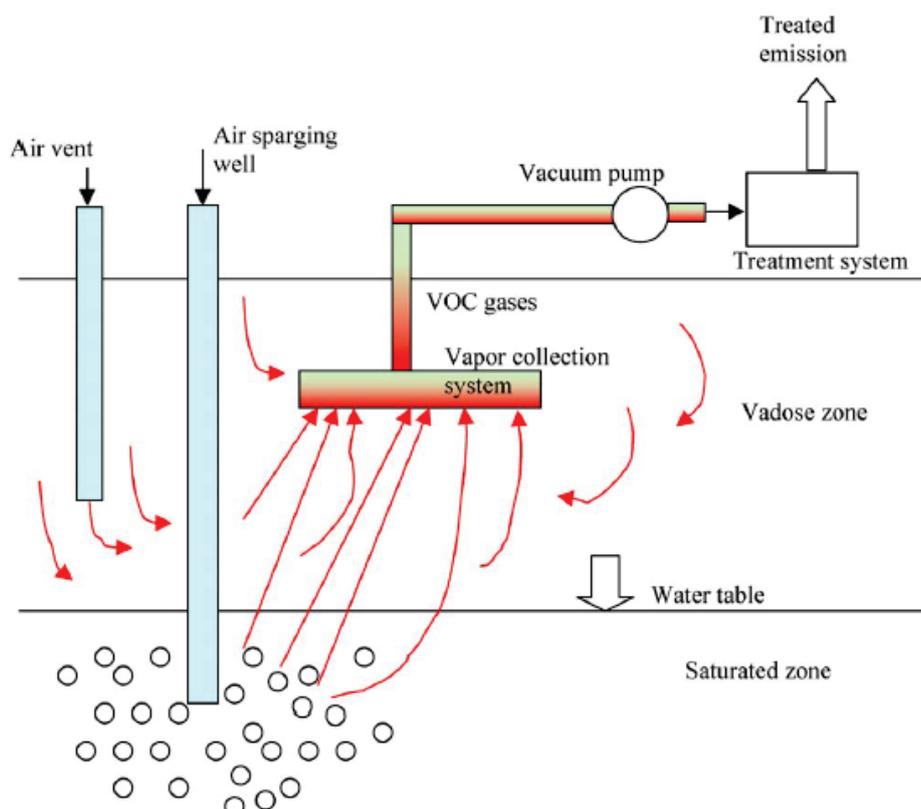
Figure 10: Soil vapour extraction for *in situ* remediation of contaminated soil (Khan et al, 2004).

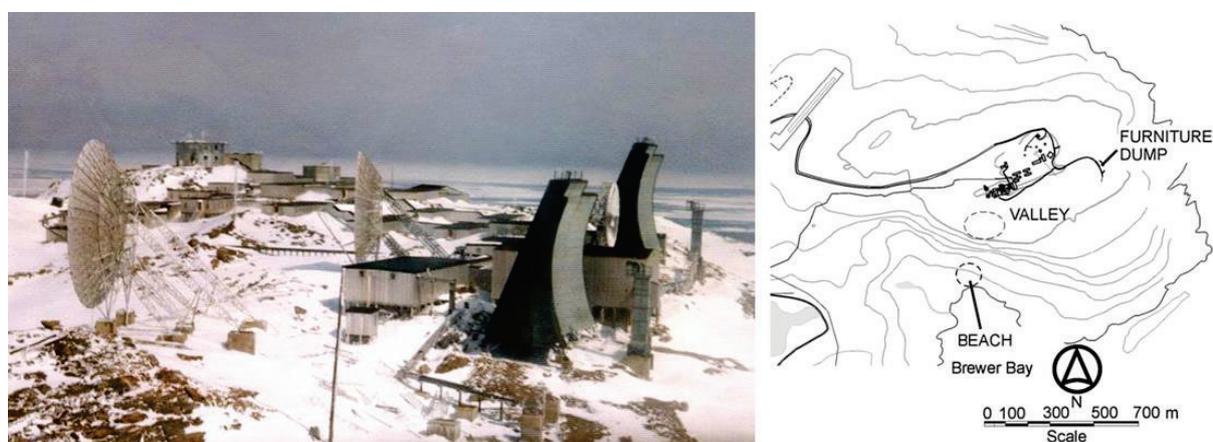
Figure 12. Resolution Island, Nunavut, Canada. Photo courtesy Rob Hopkins. Map of site and drainage barrier sites (Kalinovich et al, 2012).

Resolution Island is located at the south eastern tip of Baffin Island, Nunavut. The main DEW Line station (BAF-5) at this site resides on a summit 360 m above sea level overlooking Brewer Bay. In the summer, the area exposes bare bedrock with occasional pockets of soil. Polar bears frequent the site between June and September, and seals and whales often visit Brewer Bay. When operative (1953-1972), the base consisted of 40 permanent buildings and accommodating at most 200 military personnel. When vacated in 1972, hazardous materials such as PCBs, mercury and petroleum products were left along with barrels, debris, eight

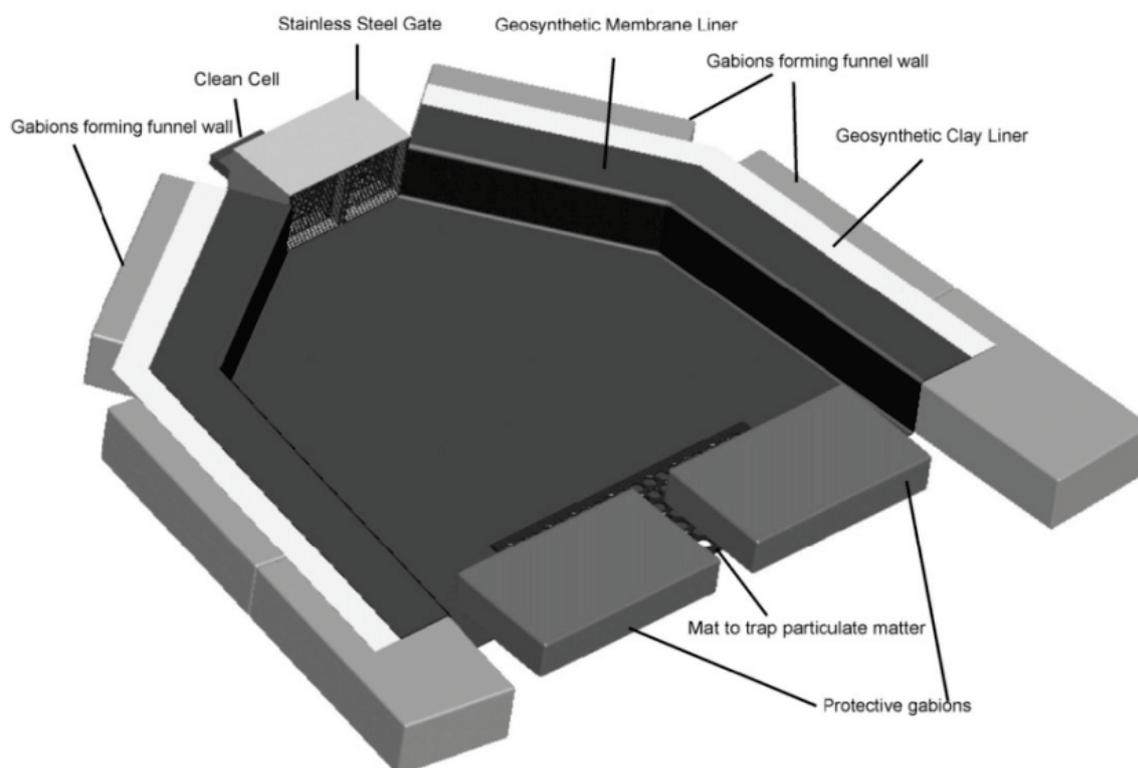
Figure 13. Prototype illustration of drainage barrier at BAF-5, stainless steel gate box dimensions 1,5×0,5 m (Kalinovich et al, 2008).

Due to leakage of PCBs from contaminated soil into the sea, three drainage barriers were designed and installed in the leachate pathways at the valley, beach and furniture dumpsites (Fig. 12). The funnel-like drainage barriers with filters were designed to retain PCB-contaminated particles transported with surface water runoff (Fig. 13). The presence of petroleum products along one of the drainage pathways led to increased transport of PCBs due to their higher solubility in these solvents as compared to water. The drainage barriers were monitored annually after installation, appearing to be highly functional with successful retention of remaining PCB-contaminated particles.

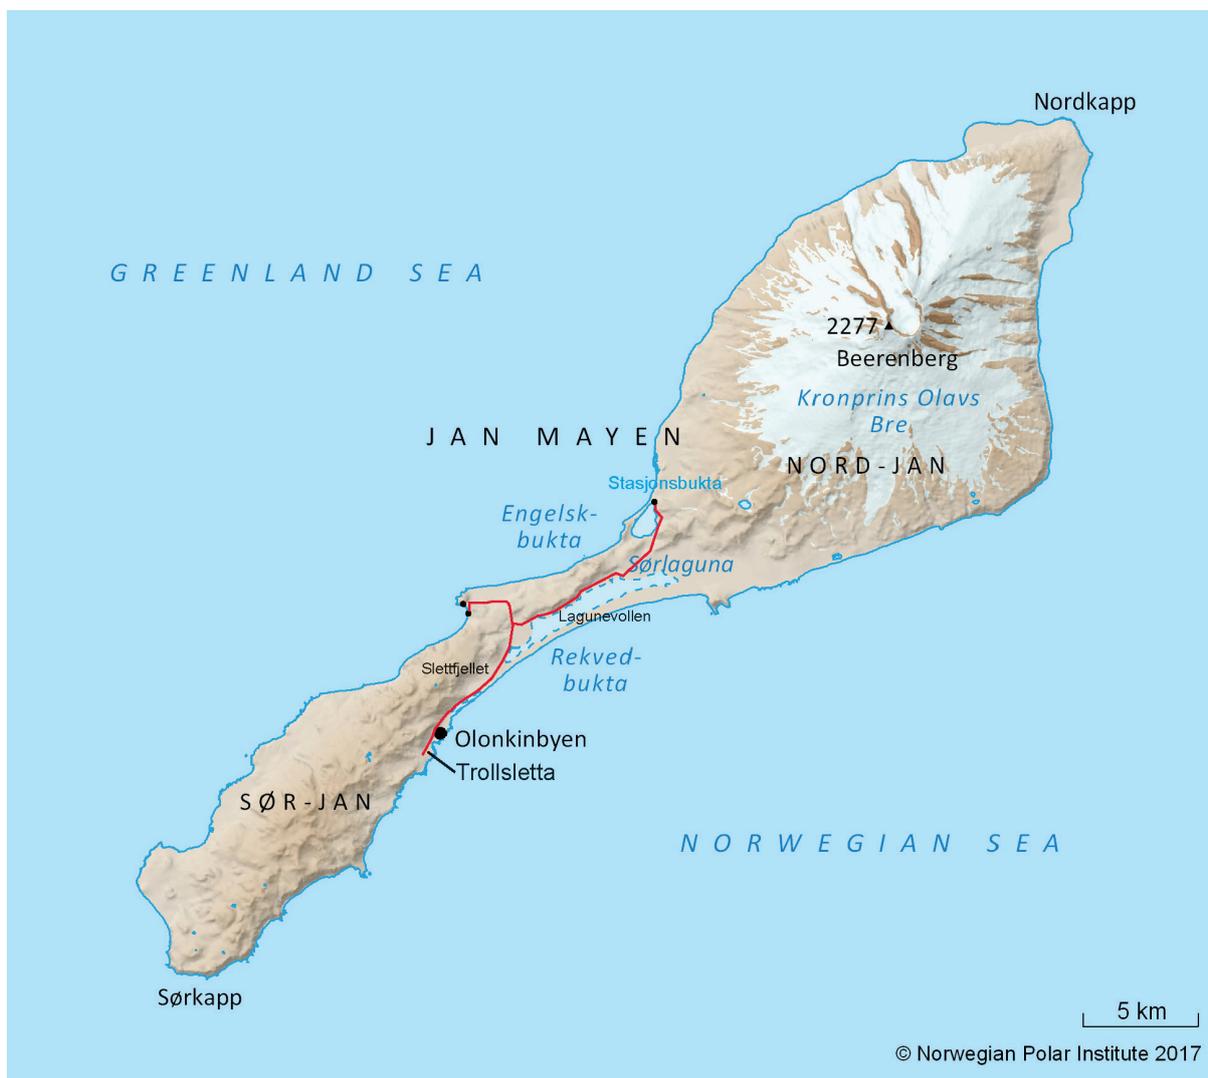
Figure 14. Jan Mayen, Norway with the Trollsletta dumpsite, <http://topojanmayen.npolar.no/>.

In 1993 and 1994 high THC ($13.400 \mu\text{g g}^{-1} \text{DW}$) and PCB ($0.2 \mu\text{g g}^{-1} \text{DW}$) concentrations were detected at the military radar station dumpsite at the settlement Olonkinbyen (Fig. 14). The PCBs originated from transformer oil, which had been deposited at the now closed dumpsite at Trollsletta. The dumpsite is located on a slope, 2-5 m from the sea shore.

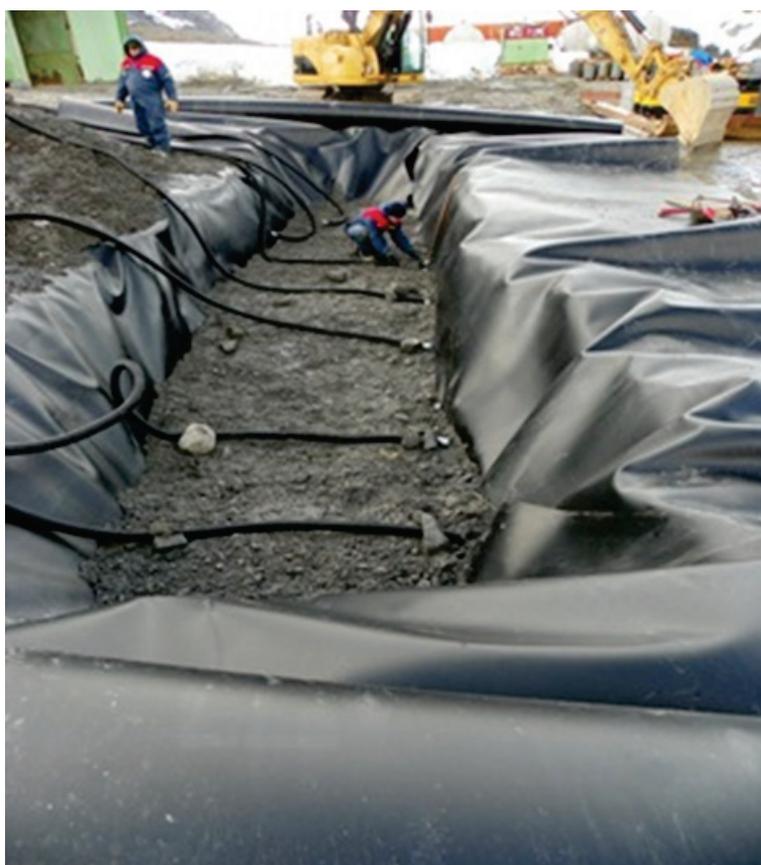
Figure 16. The Brazilian Research Station, Antarctica. Installation of a bioventing system during *in situ* remediation of diesel-contaminated soil using “biocava” techniques (ATCMXXXIX-CEP6, 2016).

Based on recommendations in the Antarctic Clean-up Manual and studies documenting the presence of hydrocarbonoclastic microbes in natural soils from the area (Cury et al, 2011; Cury et al, 2014), augmented *in situ* remediation was chosen as a plausible and cost-effective alternative for diesel clean-up. The clean-up procedures were partly experimental including the construction of a “biocava” and a biopile. Biocava construction was initiated in January 2014 where a large area (264 m²) with contaminated soil was excavated (l: 22 m, w: 12 m, d: 2.5 m). The excavated pit was lined with a geomembrane (high density polyethylene membrane, thickness 2 mm) and supplemented with aeration pipes for bioventing (Fig. 16). The excavated soil was amended with nutrients and loaded back on top of the geomembrane and pipes and covered. Increased oxygenation and nutrient supply was expected to stimulate microbial degradation and mineralization of the soil associated diesel. Biopiling of diesel-contaminated soil excavated from another part of the impacted site was initiated in January 2015. The biopile consisted of 450 m³ of diesel-contaminated soil amended with fertilizers and covered by a geomembrane (ATCMXXXVIII-CEP6, 2015a). Soil sampling is planned to be performed in the beginning and end of each summer season at both bioremediation sites to monitor the progress of diesel biodegradation (ATCMXXXIX-CEP6, 2016).

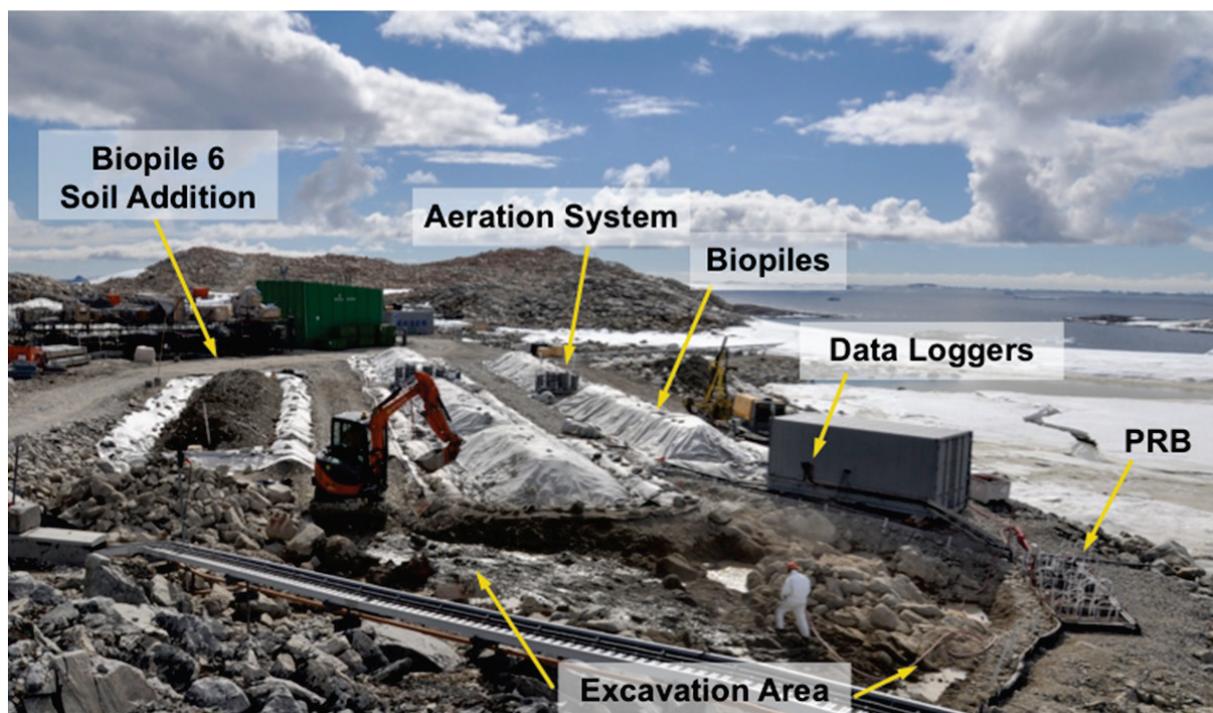
Figure 17. Remediation of fuel-contaminated soil using biopile and PRB (permeable reactive barrier) technology at Casey Station (Australian Antarctic Division). Construction site showing key features (ATCMXXXVIII-CEP6, 2015d).

In 2005 a remediation project was initiated following an oil spill at Casey Station (Australian Antarctic Division) in 1999 (ATCMXXXVIII-CEP6, 2015d). Before any remediation took place, investigations on natural biodegradation and evaporating rates were performed at the spill site concluding that the spill was almost unchanged even after five years in the Antarctic soil (Snape et al, 2006; Snape et al, 2005). Because the amount of contaminated soil was extensive and also located on a slope risking to leak contaminants into the sea, both biopiles and a permeable reactive barrier (PRB) filtering system were constructed (Fig. 17). Biopiles were amended with nutrients and aerated using a piping system. The piping system also functioned as a vapor extraction system for VOCs by applying vacuum to one side and drawing fresh air through the biopile, then leading the vapor filled air out through an activated carbon filter. After four years of operation the soil contained only one fifth of the original
